Pavement Coring Report

Project Name: East 347th Street Resurfacing

Project Number: 232528

Project Owner: City of Eastlake

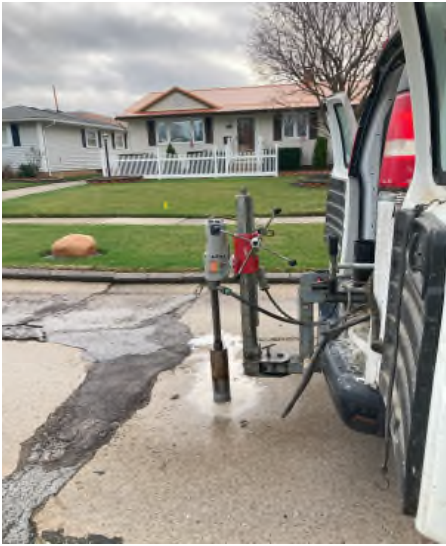
CORE LOCATION

Core #	Location	Cored Material Description	Actual Material Thickness In Inches	Plan Depth	Condition/Type of Subgrade -Aggregate Size -Remarks	
1	Hse. #1183 E. 347th St. 8'6" from back of curb. See attached map.	Concrete	7.5	N/A	2" max aggregate - limestone	
		Sub-total cored	7.5		Base material is gravel w some clay.	
2	Hse. #1124 E. 347th St. 7' from back of curb. See attached map.	Concrete	7.5	N/A	2" max aggregate - limestone	
		Sub-total cored	7.5		Base material is clay.	
		Total Cored	15.0
