HZW
Environmental
Consultants

Subject: *Report of Findings from the Asbestos Bulk Sampling of Roofing Materials Conducted at the Liberty Township Administration Building Located at 1315 Churchill Hubbard Road, Youngstown, Mahoning County, Ohio (HZW Project No. H20067-06)*

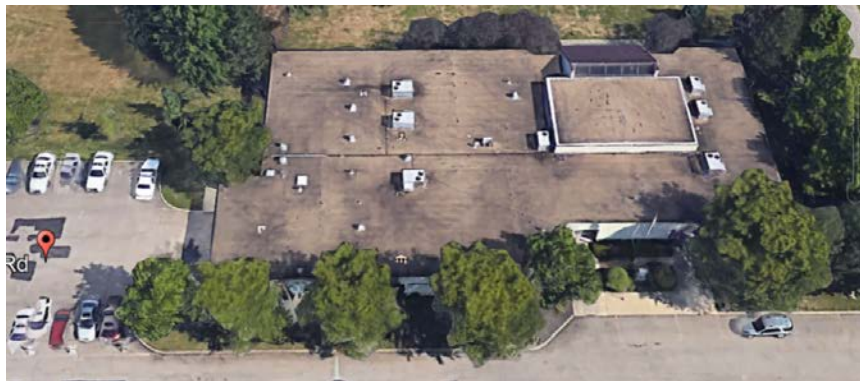
Photograph 01

Aerial View of the Liberty Township Administration Building’s Roof,
1315 Churchill Hubbard Road, Youngstown, Mahoning County, Ohio
