CITY OF HERMITAGE	ISSUED FOR:	DESIGN	ON	REVISION	
TH DARBY ROAD STORMWATER AND	ISSUE DATE:	2/20/2019			
ADWAY IMPROVEMENTS PROJECT HERMITAGE, PENNSYLVANIA	SCALE:	AS SHOWN			
	DESIGNED BY:	PMT			
SURVEY CONTROL PLAN	DRAWN BY:	PMT			
	CHECKED BY:	IAG

181039

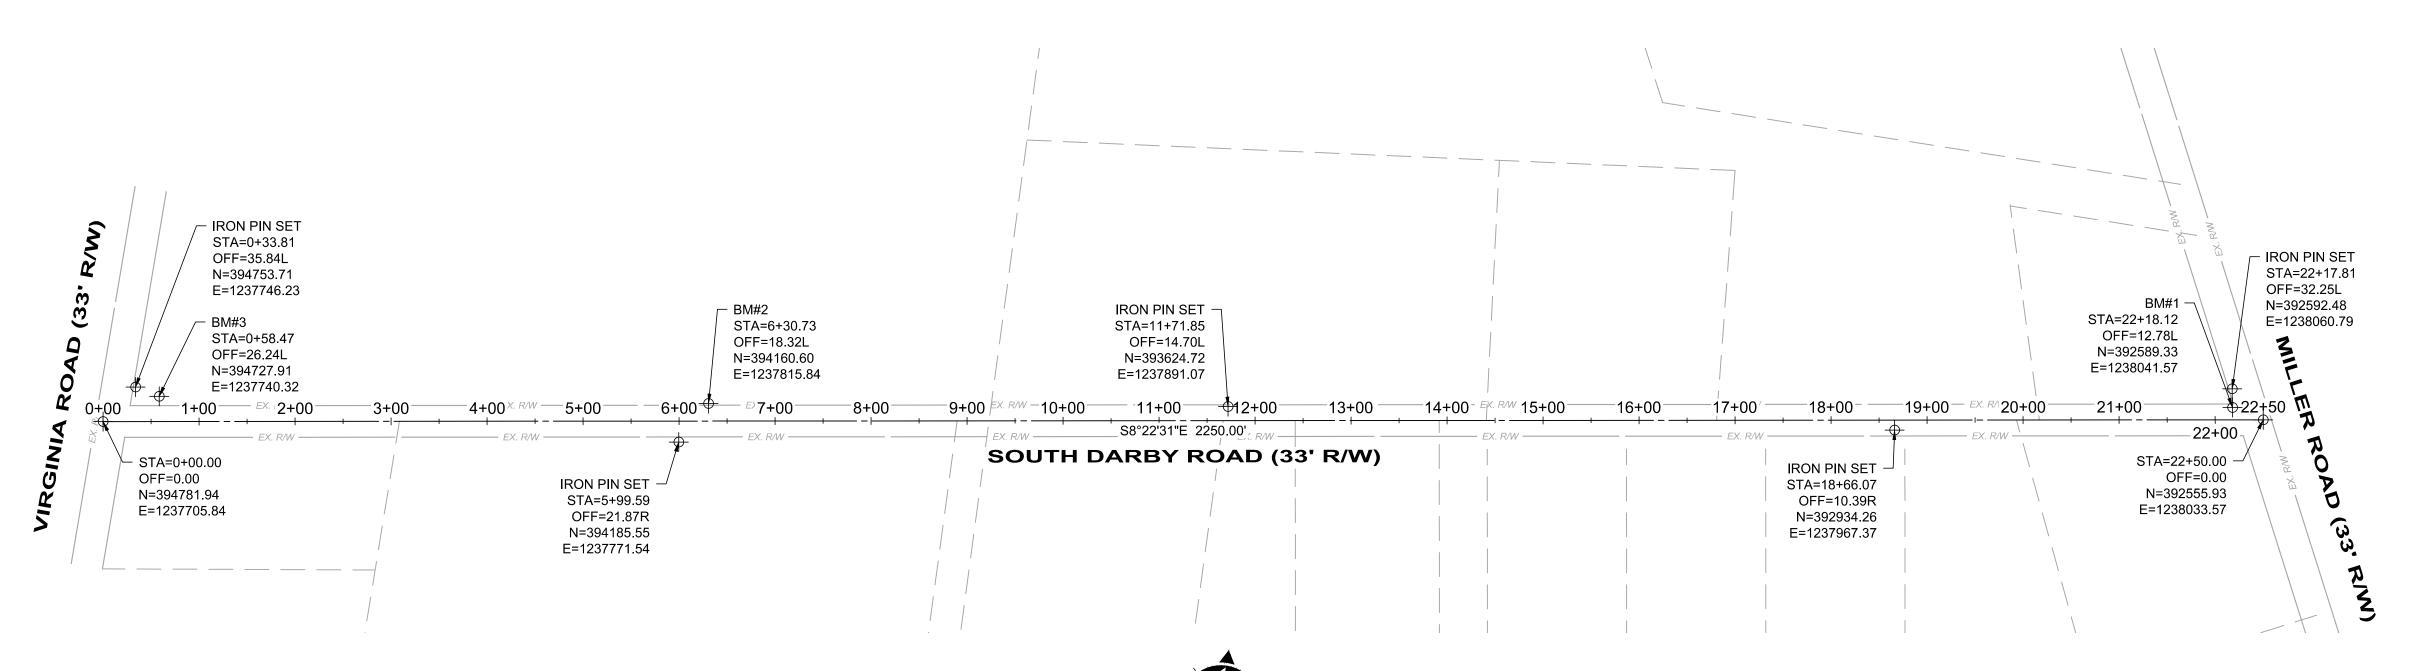
SVC

- BM#1
 BEING A CHISELED "X" ON THE NORTHWESTERLY CORNER OF A CATCH BASIN LOCATED AT THE NORTHEASTERLY CORNER OF THE INTERSECTION OF S DARBY ROAD AND MILLER ROAD. SAID CATCH BASIN BEING APPROXIMATELY 25 FEET NORTHEASTERLY FROM THE CENTERLINE INTERSECTION OF SAID ROADS.
 ELEV.=1141.52'
- 2. <u>BM#2</u>
 BEING A CHISELED "X" ON THE WESTERLY RIM OF A SANITARY MAN BEING ON THE EASTERLY SIDE ON S DARBY ROAD. SAID MANHOLE BEING IN THE FRONT YARD OF STREET ADDRESS 1227, AND BEING APPROXIMATELY 12 FEET EASTERLY FROM THE EAST EDGE OF ASPHALT OF SAID S DARBY ROAD. ELEV.=1159.56'
- 3. BM#3
 BEING A LANDSCAPE SPIKE ON THE WEST SIDE OF POWER POLE NUMBER
 276-118, SAID POLE BEING AT THE NORTHEASTERLY CORNER OF THE
 INTERSECTION OF DARBY ROAD AND VIRGINIA ROAD AND APPROXIMATELY 16
 FEET EASTERLY FROM THE EASTERN EDGE OF ASPHALT OF SAID S DARBY
 ROAD.
 ELEV.=1176.66'
